**ROGERS PASS
SNOW AVALANCHE
CONTROL - A SUMMARY**

**Glacier National Park,
British Columbia, Canada**

V.G. (Fred) Schleiss

APRIL 1990

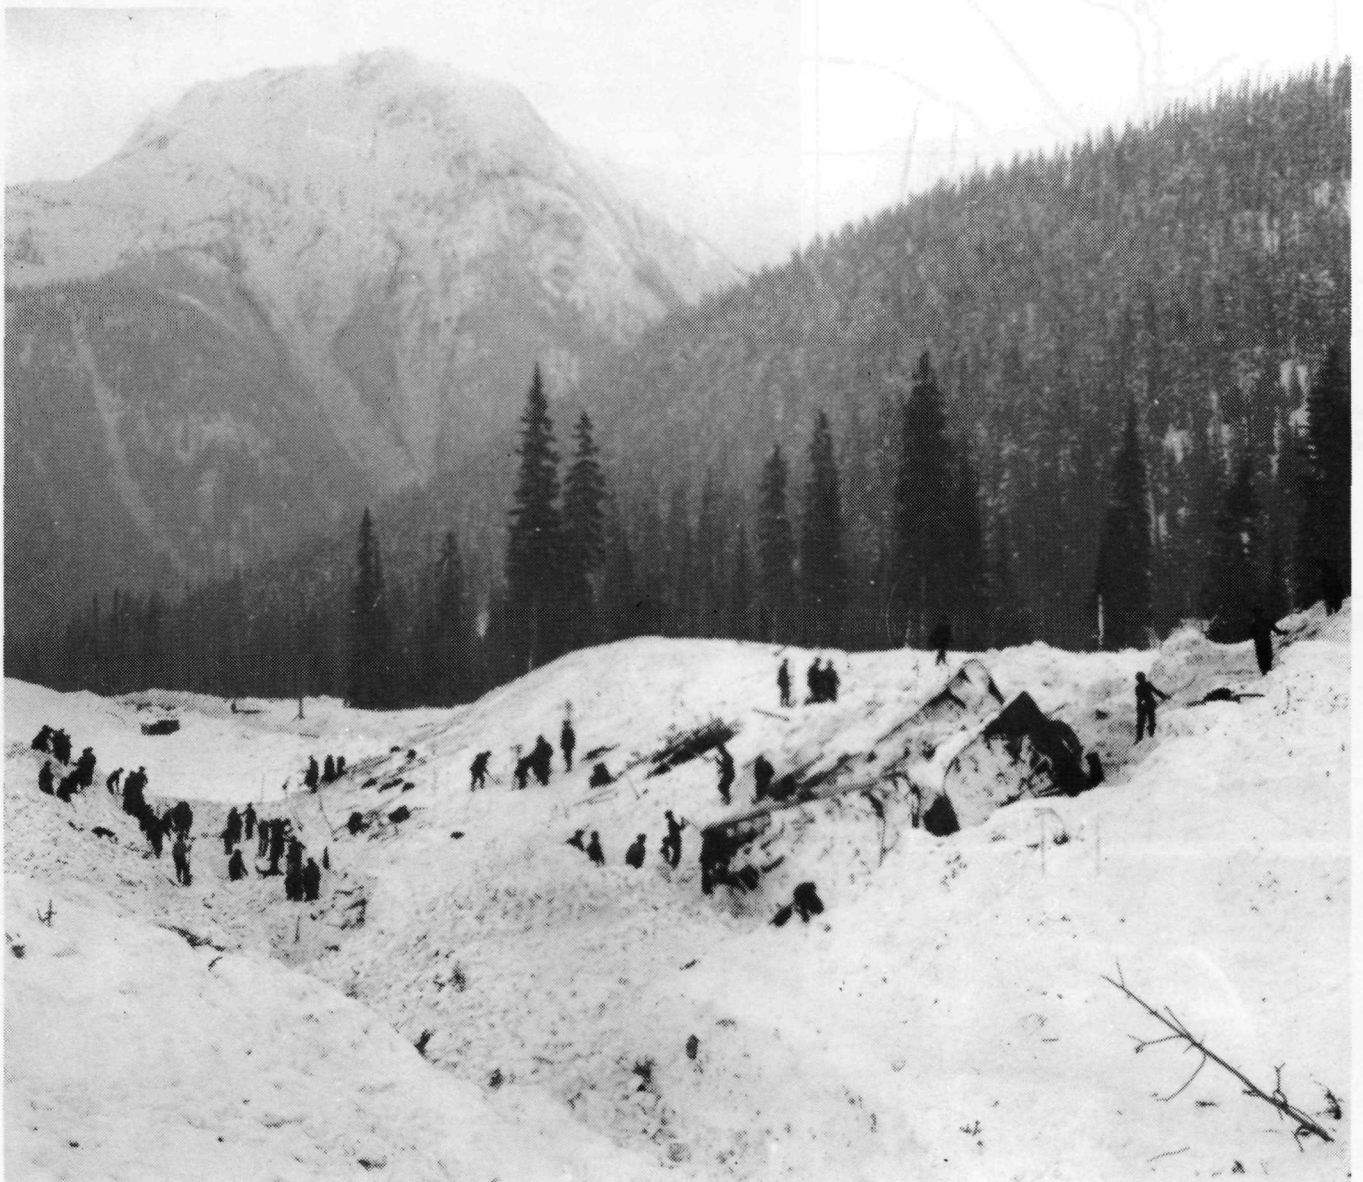
Figure 8: 1910 Disaster at 17 Shed

Previous page (clockwise from top right): 17 Shed under construction in 1887; body recovery, 1910 disaster; clearing avalanche debris after the 1910 disaster; CPR snowsheds before 1916.

From 1886 to 1909 a “valley shed” protected the railway in the overlapping runout zones of Shoulder Valley (065) and Cheops 1 (066) slidepaths (Figure 12). When the track was re-aligned outside 17 Shed in 1909, they did not protect it with a snowshed. This decision was made as a result of the inactivity of these slidepaths during the previous years. On March 4th, 1910 Cheops 1 slidepath covered the railway line. A crew working to clear snow and forest debris from the track was buried by another slide from Shoulder Valley slidepath (Figures 13 and 14). Sixty-two workers died in this incident.

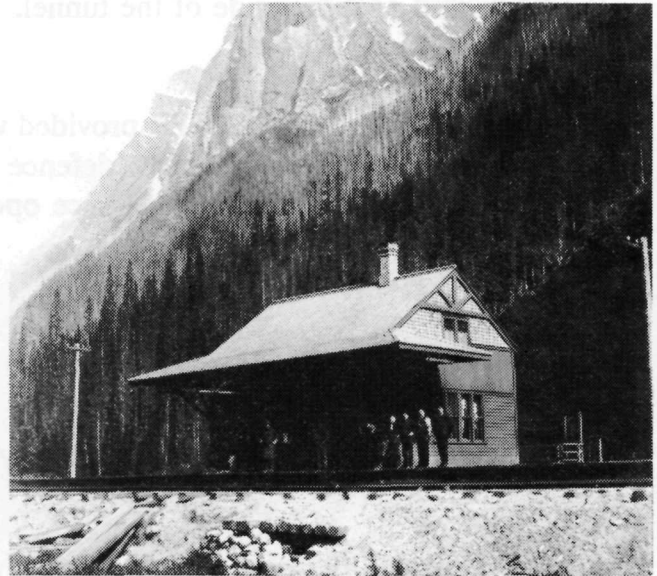
Figure 10: Rogers Pass station, 1885-99

Rogers Pass station with Mount Macdonald in the background. The avalanche path immediately behind the station is now named Tractor Shed Minor.

From 1885 to January 1899, the first Rogers Pass railway station was located in the overlapping runout zones of the slidepaths now named Tractor Shed Minor (056) and Hermit (057) (Figures 9 and 10). On January 31, 1899 a major slide from Hermit destroyed the station and killed 7 people (Figure 11). Apparently, when the CPR built the station in this location they did not realize the potential size of these avalanche paths.

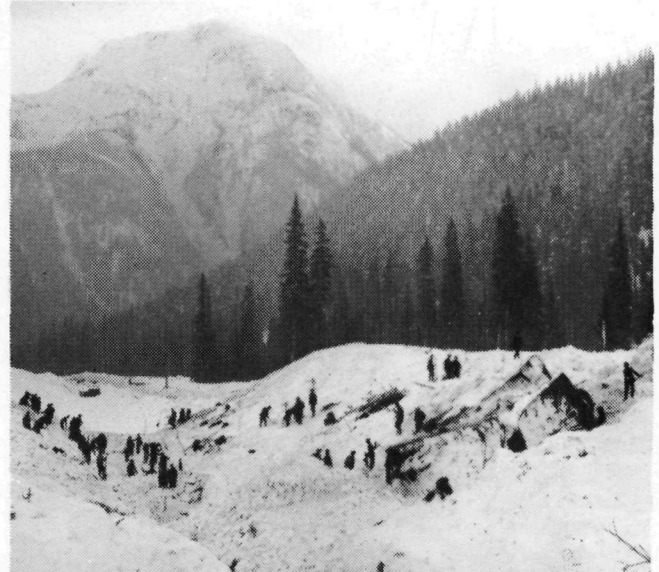
Figure 13: The 1910 disaster site, view to south

The slide swept down the slopes of Macdonald West Shoulder (to the left). The force of the avalanche lifted a rotary snowplow, weighing more than 100 tons, onto the roof of the recently abandoned 17 Shed.

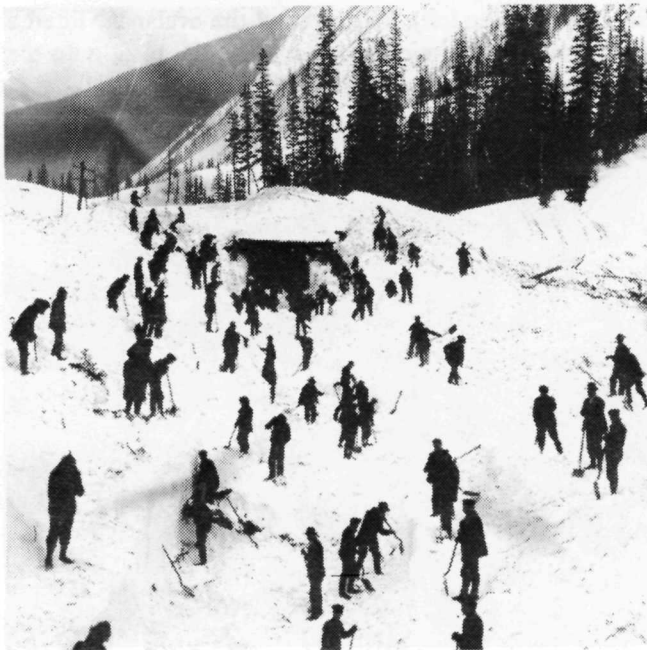
Figure 16: 14 Shed after the slide of 1910 March 10

Clearing debris near the west portal of 14 shed. Shovel gangs like these were very exposed to avalanche hazard - the previous night, 62 men in another gang died in an avalanche at the summit of Rogers Pass. Lone Pine slide (054) is on the left, Tractor Shed East (053) on the right.
